## Case Study – Forth & Clyde Canal In-house Spot Dredging October 2014

**Location:** Devil’s Elbow, Strone Point, through to Twechar Bridge (Bridge 17), Forth & Clyde Canal (see Figure 1)

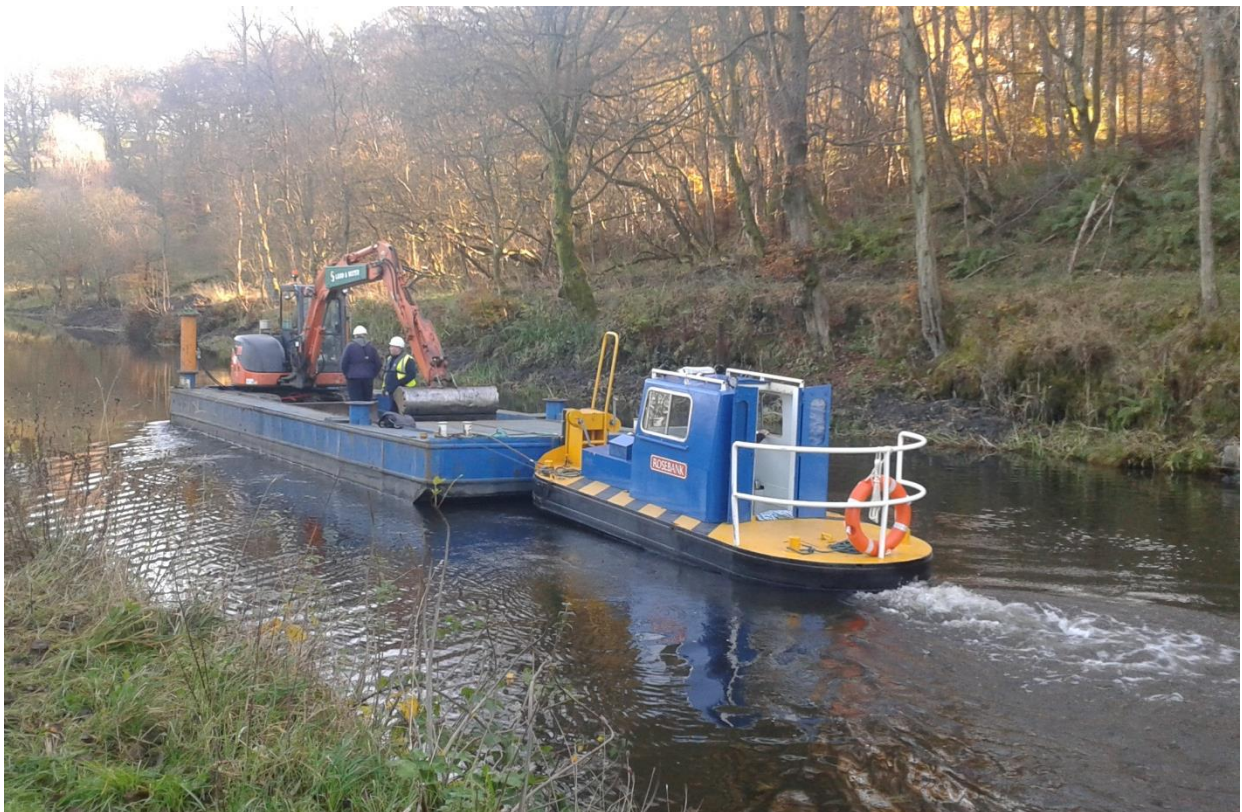
Above: tug pushing knockdown pontoon along Forth & Clyde Canal at Devil's Elbow

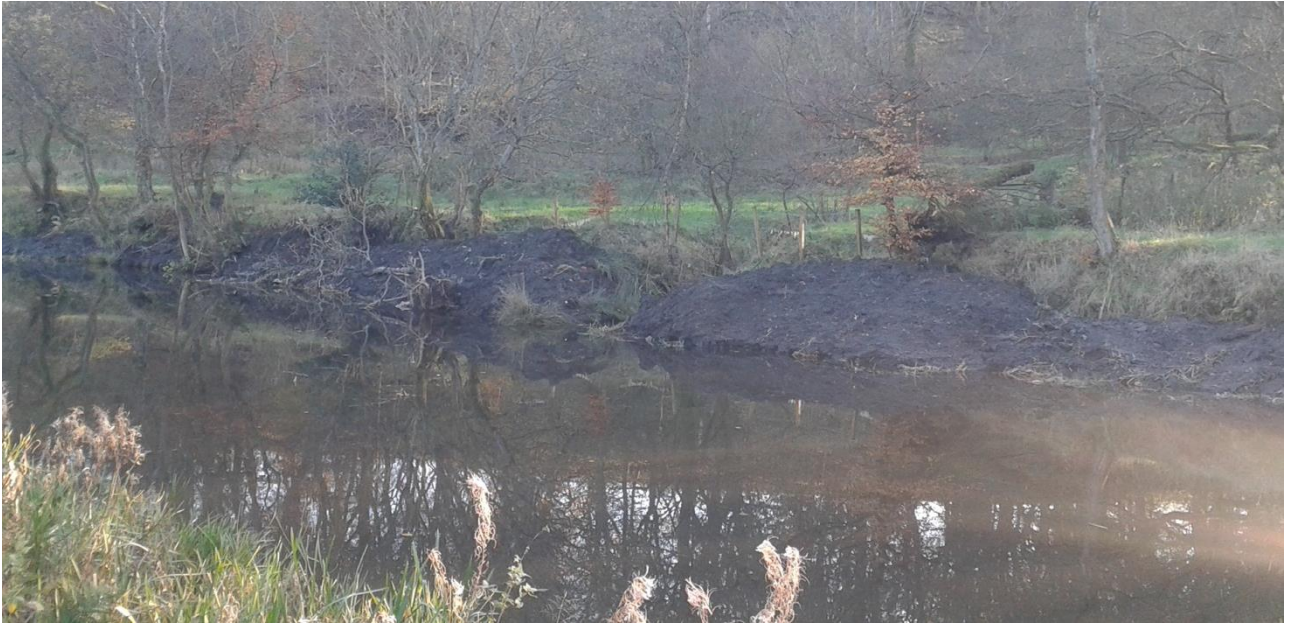
Above: bankside disposal on offside bank. Mound of material either side of burn entering canal on offside, clearly demonstrating where the burn deposits sediment underwater

**Solution:** Bank-tipping along offside bank on-site

Once all sediment analyses were available, a number of disposal options were considered for the sediment. None of the three samples were heavily contaminated, and were suitable for bankside disposal along the canal under a Paragraph 25 exemption (The deposit of dredging wastes) from Waste Management Licensing (Scotland) Regulations 2011. This reuse option doesn’t require haulage, as material is disposed of on-site, and therefore saves Scottish Canals disposal costs. Bankside disposal is also the simplest disposal option. This was desirable as SC staff would be operating dredging works for the first time, and there would be some time for training built into the work schedule at the start of the works – this was the focus of the works. SC-owned land on the offside was identified and assessed for suitability on the SC GIS system as an acceptable site for spreading material.

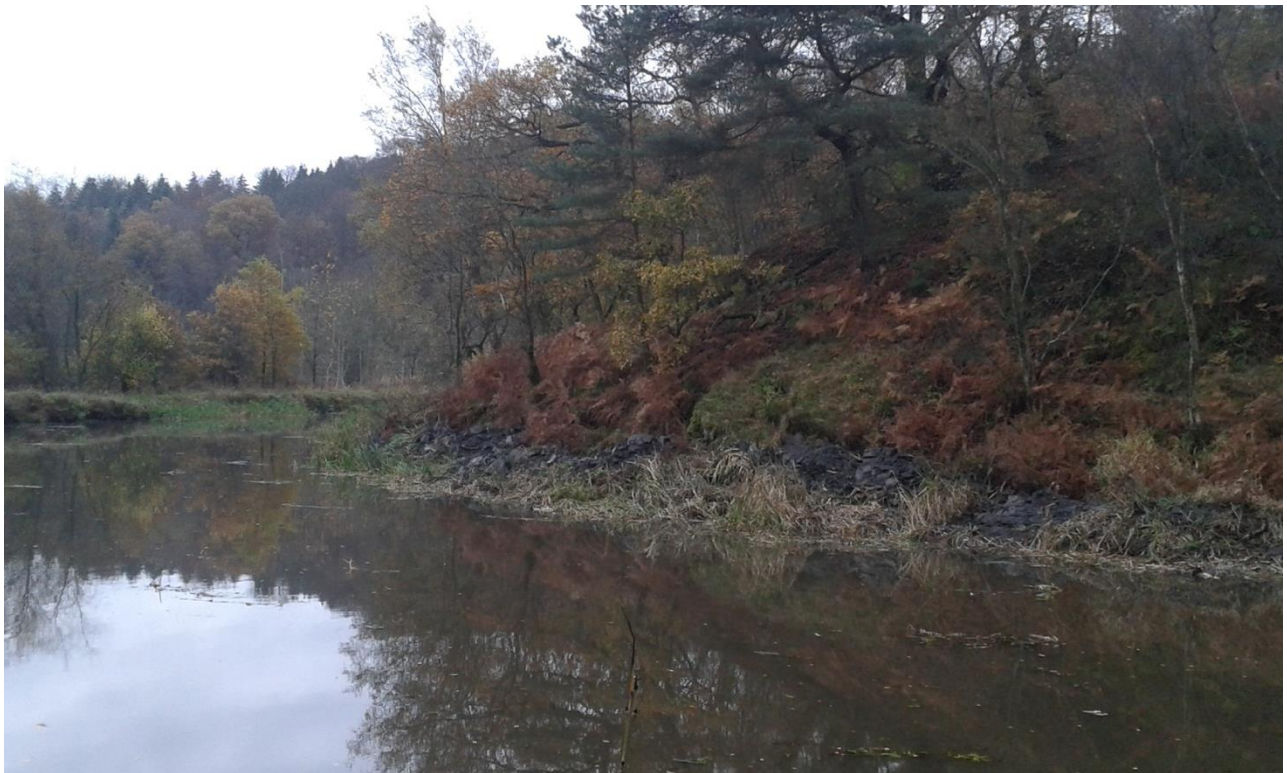
Above: Bankside disposal on offside bank at Strone Point on Forth & Clyde Canal
